# Manhole Inspection Summary

Manhole # S41CC\_063MH

Insp Date: **12/12/07 10:06 AM**

**Location** Address: **eden and eager park**

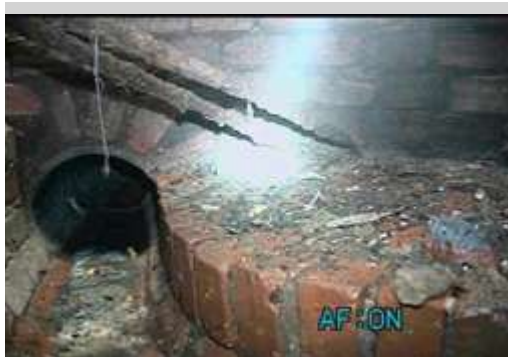
Miscellaneous

bench debris

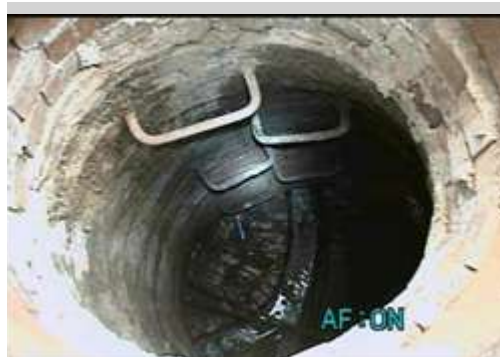
Defect 3

**Steps** Count: **5** Missing: **0** ☒ **Corroded**

steps

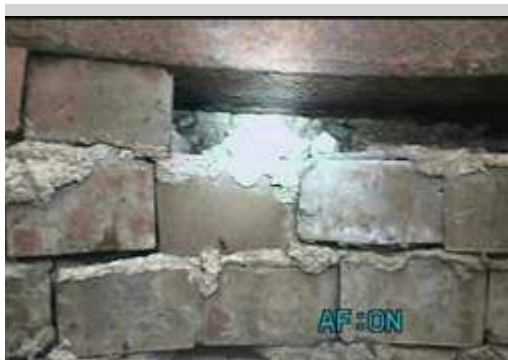
Defect 1

Condition: ☐ Sound ☐ Cracked ☐ Root Intrusion ☒ **Loose Brick** ☒ **Deteriorated**

corbel loose bricks, deteriorated

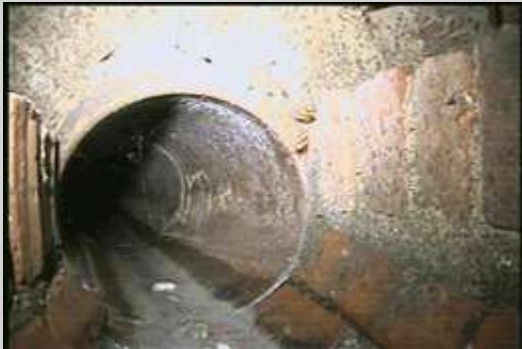
12 O'Clock Outflow

8 in. Circular Gravity Sewer  
Pipe Out @ 12 O'Clock

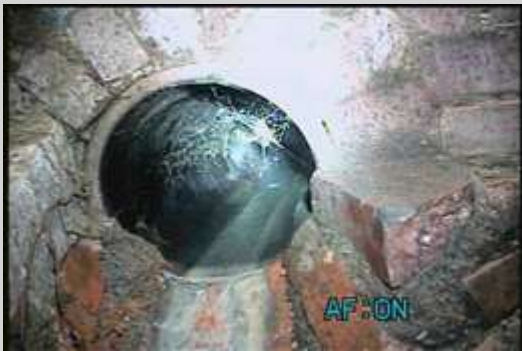
6 O'Clock Inflow

8 in. Circular Gravity Sewer  
Pipe In @ 6 O'Clock

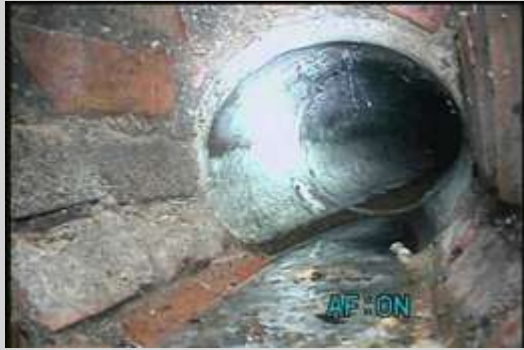
8 O'Clock Inflow

8 in. Circular Gravity Sewer  
Pipe In @ 8 O'Clock
